## 32 EAST 64TH STREET New York City

# Tech Notes

## Restoring Metal Roof Cornices

Richard Pieper  
Director of Preservation  
Jan Hird Pokorny, Architects and  
Planners

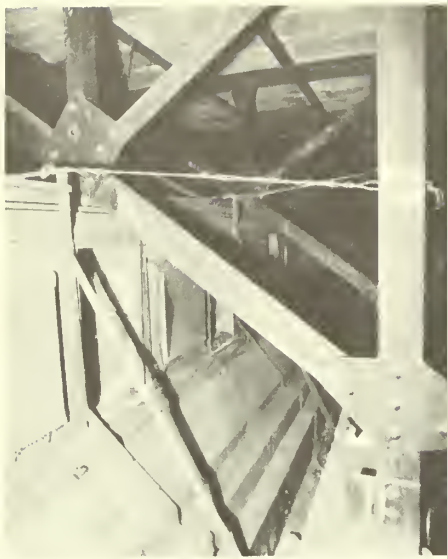
Figure 1. Large steel trusses cantilever out from the masonry parapet to support the cornice. Metal facing of the cornice was bolted to small iron or steel ribs (as at left). Wire ties helped to pull the center of the cornice tight to the bottom member of the truss. Photo: Richard Pieper.

The unusually large size of the cornice made it possible to inspect its interior (see figure 1). It was accessible through two small hatches in the sloped roof covering the rear of the cornice trusses. The cornice itself is supported by steel trusses, which are in turn attached to the structural steel frame of the building (see figure 2). The top and rear slopes of the cornice trusses are covered with structural clay tiles supported by 2" steel tee purlins set perpendicular to the trusses. The tiles served as a base for the terne-plated steel standing seam roofing, which had rusted through in spots on the top slope. The standing seam roof on the rear slope of the cornice had been coated with asphalt but was in

relatively good condition. In spite of recurrent leakage, the tiles were in satisfactory condition, and the trusses showed only small areas of superficial rusting. The galvanized steel facing of the cornice was generally in good condition, but about 30 lineal feet (roughly 10 percent) of the steel at the base of the cornice had rusted where the galvanized facing entered the masonry wall. (Water leaking into the cornice had collected there.) In addition, large rust holes had formed behind nearly all the decorative lions' heads on the crown of the cornice, where holes in the exposed and seldom painted ornament allowed bird nests and moisture to accumulate. The metal of the cornice soffit was in surprisingly good condition, perhaps because water entering there was able to weep through lapped seams of the steel facing.

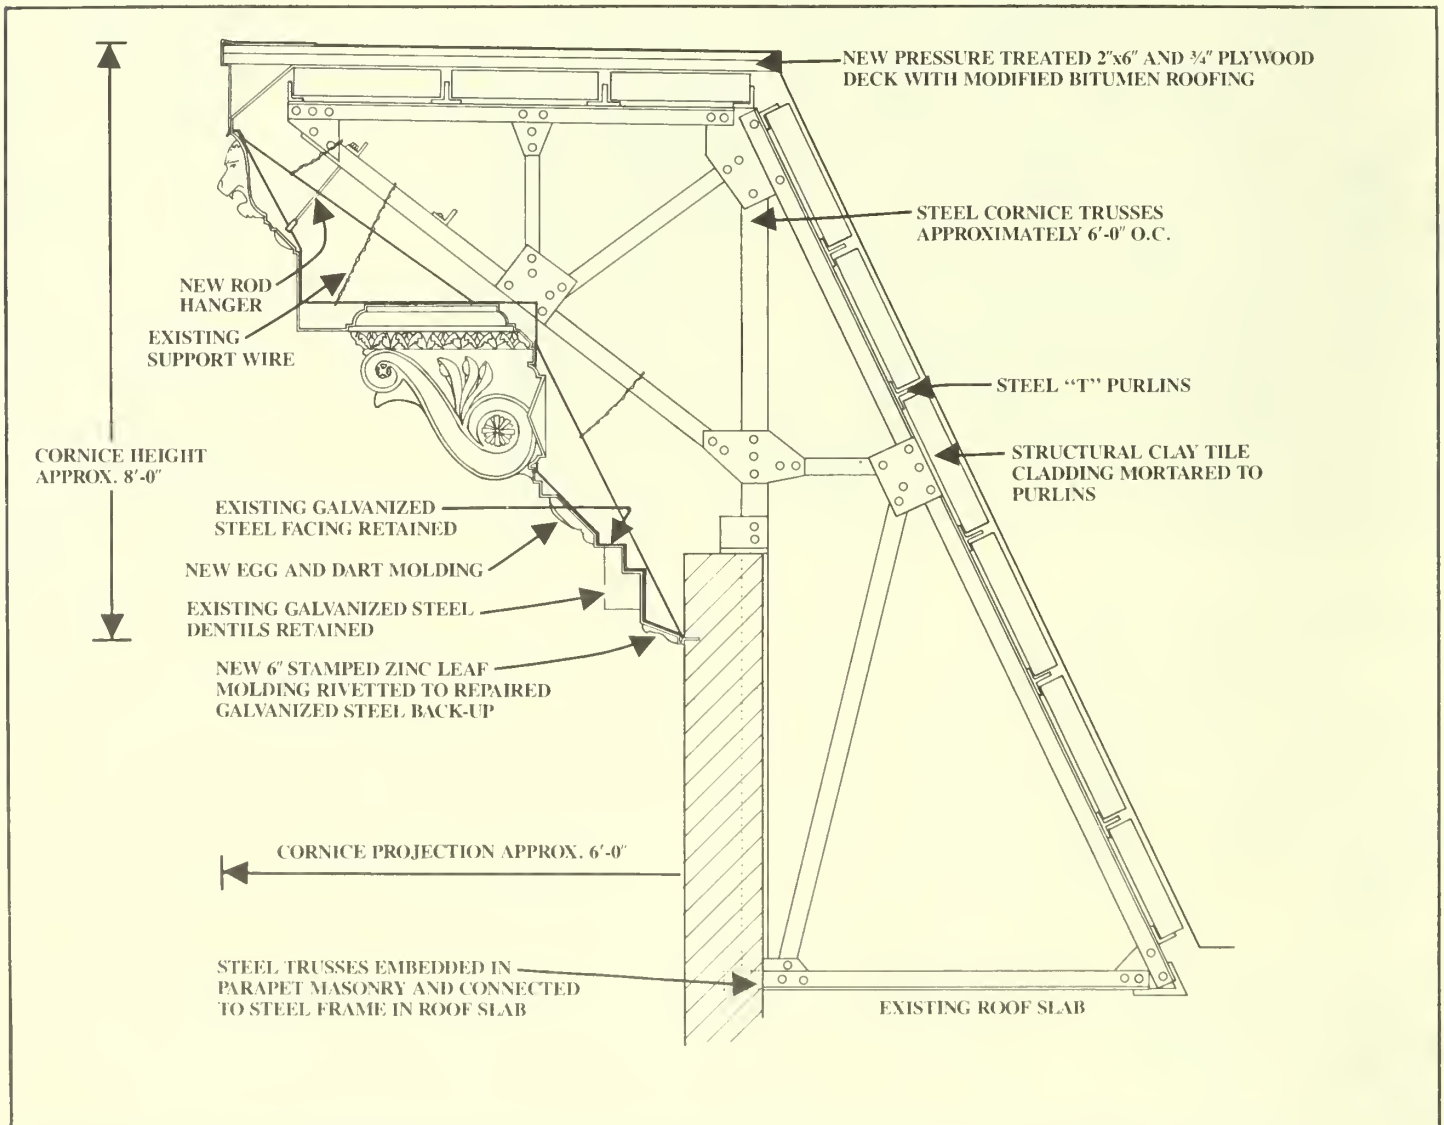
Figure 2. Cornice section shows the manner in which the cornice was supported and attached to the building. Drawing: Michael Devonshire.

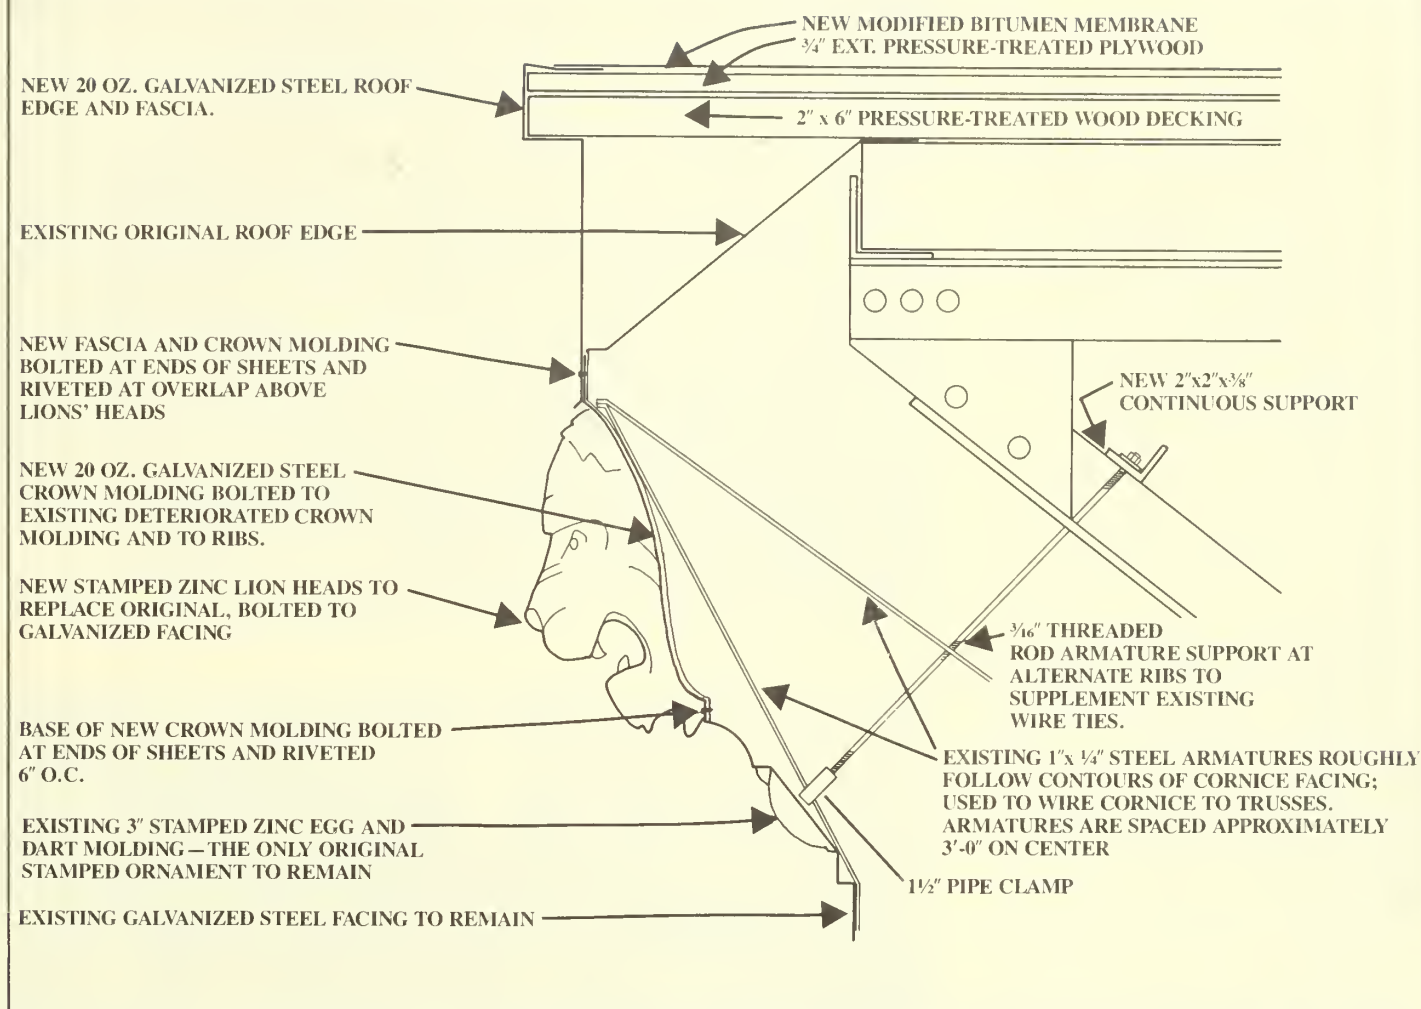
cornice above the crown molding (see figure 3). Perhaps due to a fabrication error, the trusses were too tall to receive the cornice facing as designed. Since the facing could not be raised further vertically without the top inside corner of the modillions touching the bottom chord of the trusses, a gap existed between the top of the sheet metal facing and the cornice roof when the facing was installed. The gap was closed by a short sloped piece of galvanized steel sheet metal that was not visible from the street.

Figure 3. Detail section shows the new cornice crown molding, edge cap and roofing that corrected a construction flaw in the original fabrication. Drawing: Michael Devonshire.

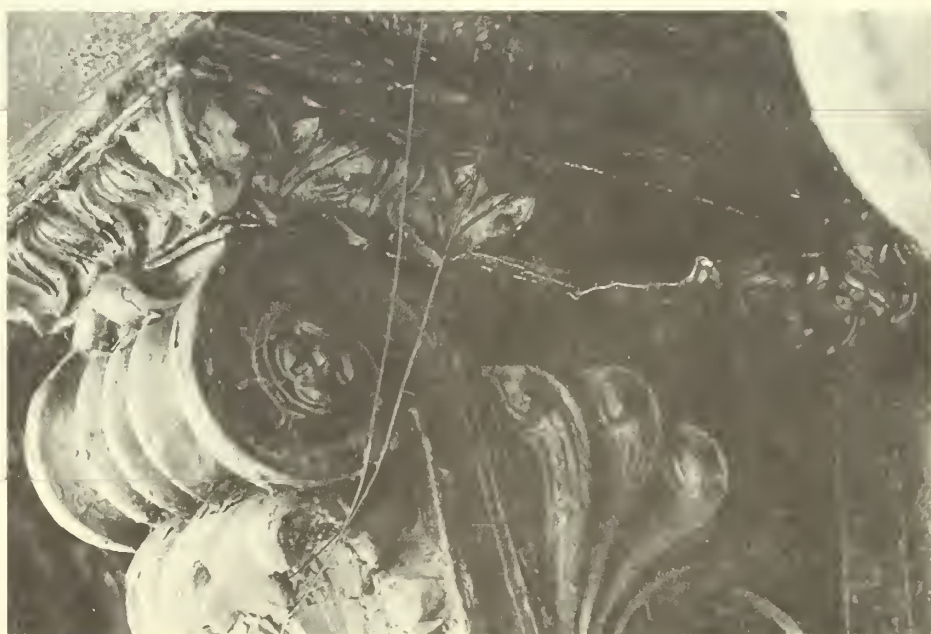
By far the most serious problem with the cornice was the deterioration of the stamped zinc ornament applied to the exterior of the galvanized steel facing. The large 12"-wide zinc modillions projected 24" from the cornice entablature and were in poor condition. The stamped zinc had fractured where integral leaf moldings met the scrolled sides of the modillions, allowing them to separate from the soffit. As a previous temporary safety measure, holes had

Figure 4. As shown in this view, the molding applied to the modillions was extremely deteriorated. A more serious problem was that most of the zinc modillions had fractured where the integral leaf moldings met the scrolled sides, allowing them to separate from the soffit. As a previous temporary safety measure, holes had been cut in the soffit panels to pass supporting wire beneath the modillions. Photo: Richard Pieper.

been cut in the soffit panels to pass supporting wires beneath the modillions (see figure 4). Cracks indicative of metal fatigue were also present in the fronts and sides of the modillions.

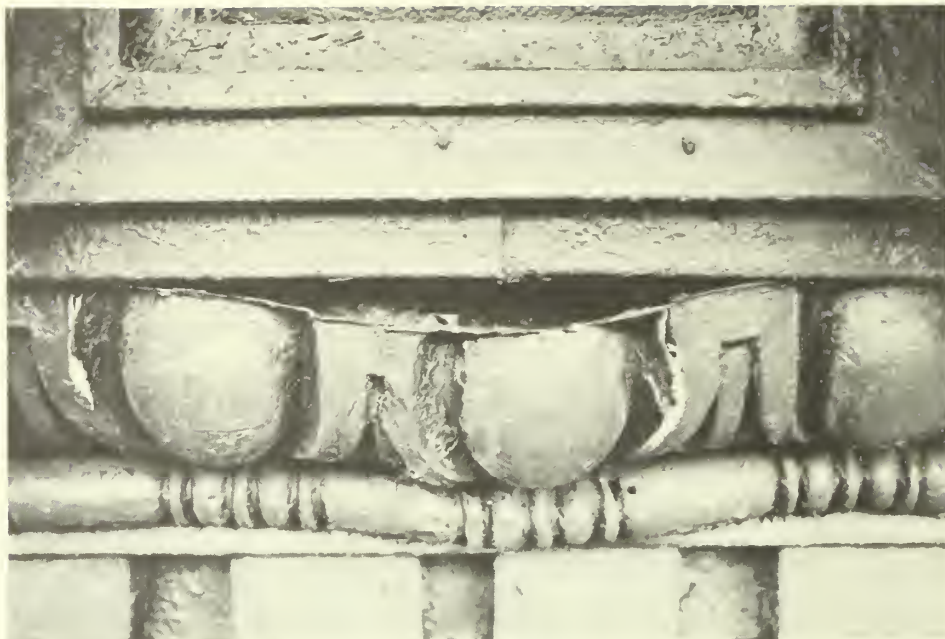
Most of the applied stamped zinc moldings were also extremely deteriorated. The cornice had been infrequently painted, and much of the ornament was thinned, perforated or broken through dissolution and embrittlement of the zinc. Lions' heads on the crown molding could easily be punctured and were tenuously attached to the galvanized steel with deteriorated soldered joints. Sections of leaf molding and egg and dart molding at the base of the cornice had fallen or been removed. The remaining molding was in poor condition (see figure 5).

Figure 5. Most of the egg and dart molding on the cornice had deteriorated over the years and required replacement. Photo: Richard Pieper.

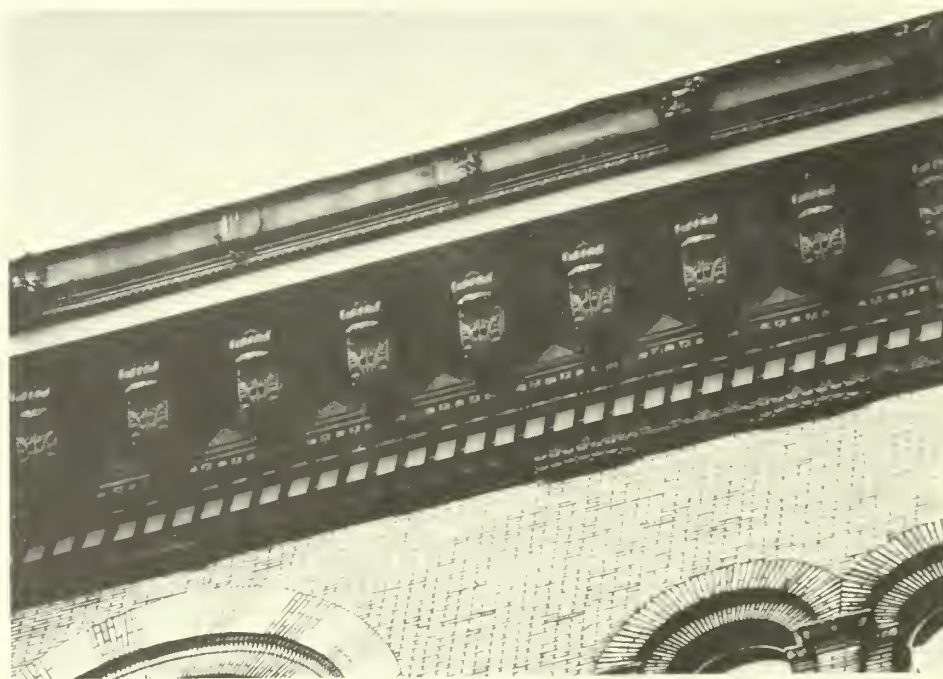
Figure 6. Three of the components of the metal cornice which required replacement because of serious deterioration are shown in this view. They are the lions' heads on the crown molding (several are missing due to failed soldered joints), modillions, and the egg and dart molding at the base of the cornice. The brake-formed galvanized steel that comprised the lineal moldings of the cornice, the soffit and dentil band were in sound condition. Photo: Richard Pieper.

Inspection showed that the galvanized steel facing of the cornice was in repairable condition but that much of the applied zinc ornament was not salvageable. The trusses supporting the cornice, the steel tee purlins and the structural clay tile were generally in excellent condition. Budget estimates were prepared for repair-in-kind and for replacement of the cornice. The architects considered two replacement alternatives; one with new metal and one with glass-fiber reinforced plastic. Repair of the existing cornice facing was the most economical alternative. The New York City Landmarks Preservation Commission also favored repair rather than replacement. Repair of the cornice included replacement of all modillions and nearly all applied zinc moldings; installation of new galvanized steel crown molding and cornice roof edge details; placement of new roofing on the top of the cornice; insertion of new rod hangers to supplement existing wire hangers supporting the face of the cornice, and repainting both the interior and exterior (see figure 6).

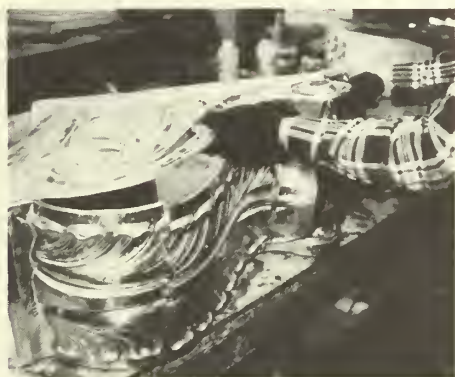
Figure 8. The modillions consisted of 6 stamped pieces soldered together by the installer. Photo: Richard Pieper.
